NASA Technical Paper 1524

Lubricating and Wear Mechanisms for a Hemisphere Sliding on Polyimide- Bonded Graphite Fluoride Film

Robert L. Fusaro

AUGUST 1979

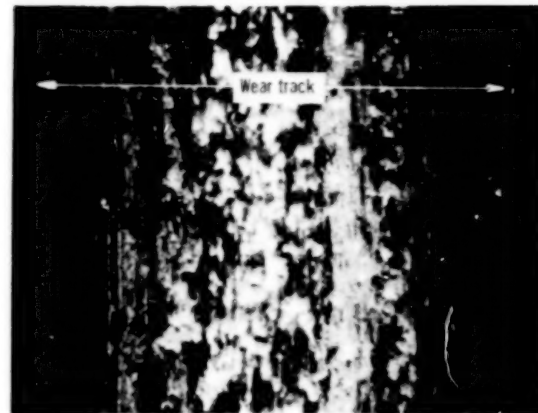
(a) After 60 kilocycles of sliding.

(b) After 500 kilocycles of sliding.

(c) After 900 kilocycles of sliding.

(d) After 1800 kilocycles of sliding.

Figure 7. - Photomicrographs of wear track on 18-micrometer-thick polyimide-bonded graphite fluoride film after sliding intervals of 60, 500, 900, and 1800 kilocycles. Rider and disk substrate material, 440C HT stainless steel; rider radius, 0.476 centimeter (hemispherically tipped); load, 1 kilogram; sliding speed, 2.6 meters per second (1000 rpm); temperature, 25° C; atmosphere, moist air (10 000 ppm H₂O).

Once the original film was worn away, asperities on the 440C HT stainless-steel substrate interacted with the rider and helped to support the load (figs. 5(d) and 6(d)). Figures 7 and 8 illustrate that the lubricating mechanism of polyimide-bonded graphite fluoride films (after the original film was worn away) was very similar to the lubricating mechanism for rubbed (burnished) graphite fluoride films (ref. 7).

Figure 7 shows photomicrographs of polyimide-bonded graphite fluoride wear tracks after 60, 500, 900, and 1800 kilocycles of sliding. The figure reveals that two things happened in the wear track as a function of sliding duration. First, the area of each individual plateau increased, indicating the truncation of the metallic asperities; and second, the wear track width increased, indicating rider wear.

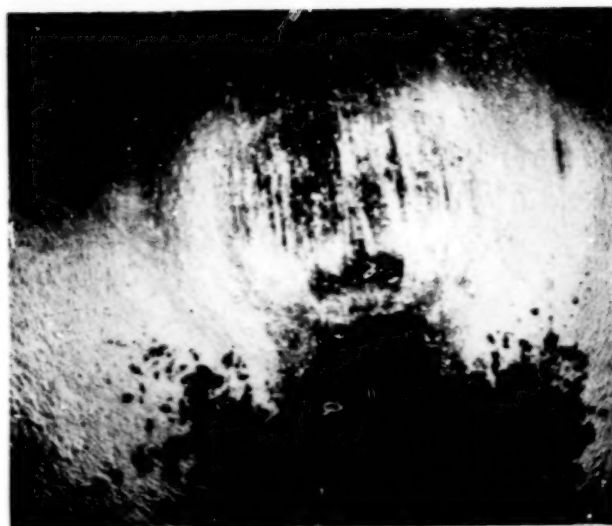
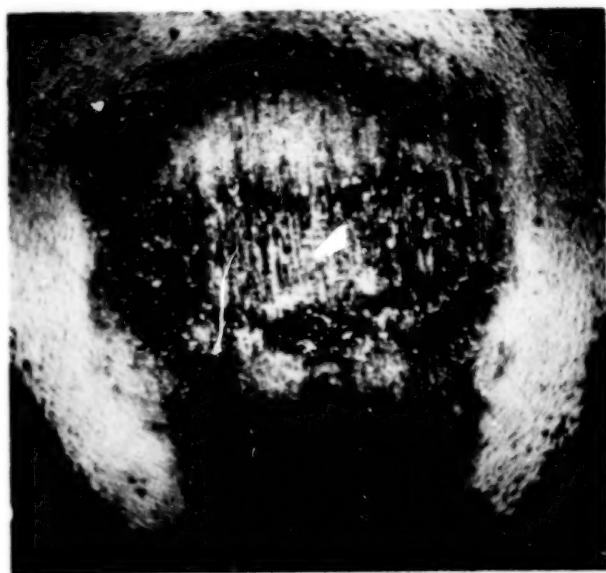
(a) After $\frac{1}{4}$ kilocycle of sliding.

(b) After 1 kilocycle of sliding.

(c) After 5 kilocycles of sliding.

(d) After 15 kilocycles of sliding.

Figure 9. - Photomicrographs of 440C HT stainless-steel-rider contact areas after $\frac{1}{4}$, 1, 5, and 15 kilocycles of sliding on 18-micrometer-thick polyimide-bonded graphite fluoride film. Substrate material, 440C HT stainless steel; load, 1 kilogram; sliding speed, 2.6 meters per second (1000 rpm); temperature, 25°C; atmosphere, moist air (10 000 ppm H₂O).

Photomicrographs of rider contact areas that correspond to the film wear tracks of figure 5 are shown in figure 9. During the sliding interval of 0 to 15 kilocycles, none or very little interaction occurred between the metallic asperities on the disk substrate and the rider. Thus essentially no wear occurred to the rider, and only a thin transfer film of polyimide-bonded graphite fluoride was present on the rider.

As long as the metallic, hemispherically tipped rider slid on the polyimide-bonded graphite fluoride film with no interaction between the rider and the sandblasted asperities, no detectable wear occurred to the rider (fig. 9). Only film transfer was observed. Interaction with the sandblasted asperities caused the rider to wear. The thicker the film, the lower the rider wear rates obtained - most likely because the sides of the wear track helped to support the load and there was less load on the metallic asperities.

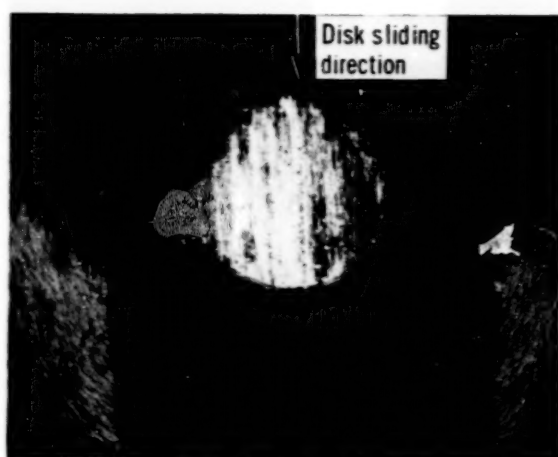
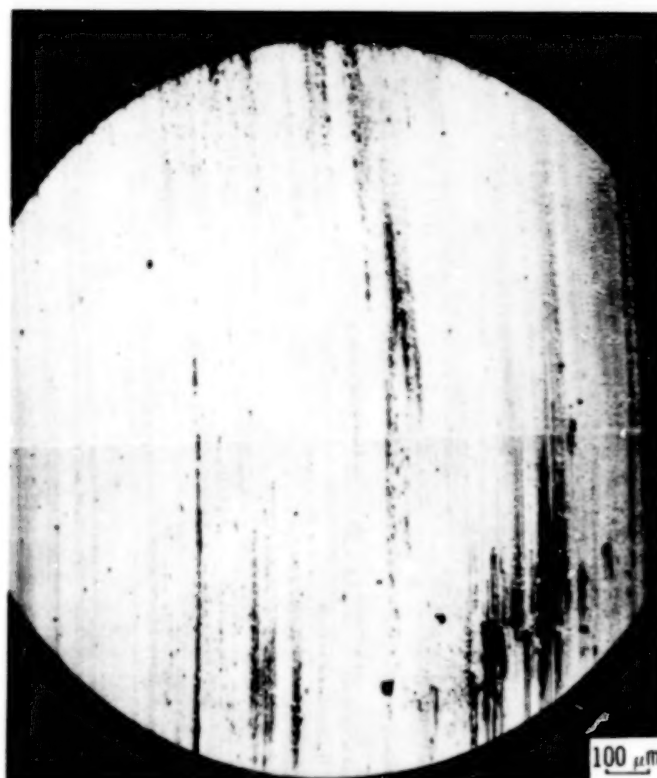
(a) After 60 kilocycles of sliding.

(b) After 500 kilocycles of sliding.

(c) After 900 kilocycles of sliding.

(d) After 1800 kilocycles of sliding.

Figure 11. - Photomicrographs of 440C HT stainless-steel-rider contact areas after 60, 500, 900, and 1800 kilocycles of sliding on 18-micrometer-thick polyimide-bonded graphite fluoride film. Rider and disk substrate material, 440C HT stainless steel; rider radius, 0.476 centimeter (hemispherically tipped); load, 1 kilogram; sliding speed, 2.6 meters per second (1000 rpm); temperature, 25° C; atmosphere, moist air (10 000 ppm H₂O).

Once the polyimide-bonded graphite fluoride film was worn through and the rider made contact with the sandblasted asperities on the disk, wear occurred to the rider. Figure 11 shows the wear scar on the hemispherically tipped rider after 60, 500, 900, and 1800 kilocycles of sliding. These photomicrographs correspond to those of the film wear tracks in figure 7.

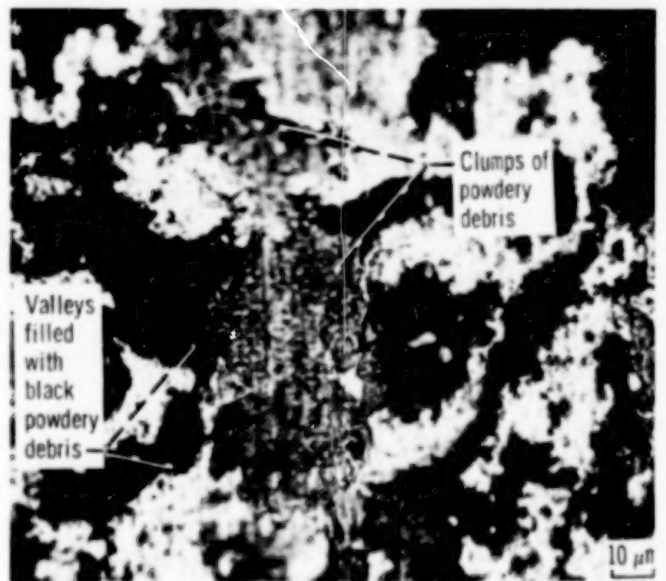
(a) Rider contact area after 4400 kilocycles of sliding.

(b) Film wear track after 4400 kilocycles of sliding.

Figure 14. - Photomicrographs of rider contact area and film wear track area after failure (high friction) had occurred. Film thickness, 45 micrometers; rider and disk substrate material, 440C HT stainless steel; rider radius, 0.476 centimeter (hemispherically tipped); load, 1 kilogram; sliding speed, 2.6 meters per second (1000 rpm); temperature, 25°C; atmosphere, moist air (10 000 ppm H₂O).

Figure 14 shows photomicrographs of the rider contact area and the film wear track area on the 45-micrometer-thick film after failure occurred. The photomicrographs also typify what happened on the 10- and 18-micrometer-thick films. The depletion of the polyimide-bonded graphite fluoride in various regions on the wear track resulted in the excessive production of extremely fine metallic wear particles. The resulting powdery mixture extended in a band (or bands) that ran around the entire circumference of the disk wear track. A matching band was found on the rider.
